Update Instructions

SP018/03/S

Title: Hardware check Motor Drive

UROSOP D1 with Polydoros LX

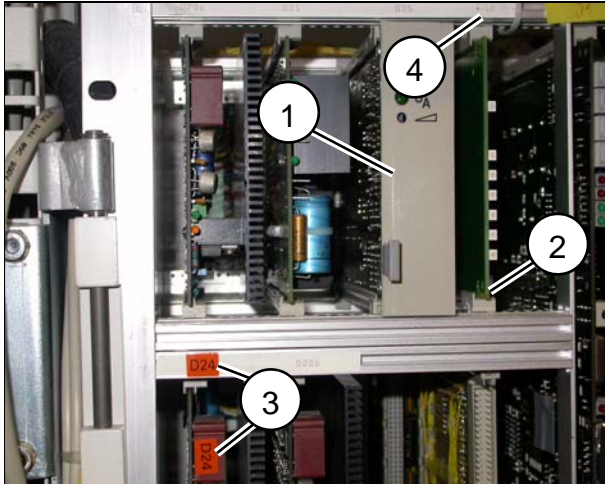
Fig. 1

In addition to the software monitoring of the movement commands to the motor controller and the feedback from the motor controller, the output stages of the motor controller for table tilt and table longitudinal movement are switched in through additional hardware on release of the movement command and switched off again at the end of the movement command.

- Remove the board D25 (1/Fig. 1).
- Swivel out the control unit M20.
- Remove any EMC covers.
- Connect the socket connector for board D23 to the slot next to board D25 (2/Fig. 1). Use the supplied slotted cap screws for this. If there are no threads available in the control frame, then use self-tapping screws M2.5 x 8 with Phillips head.
- Label the slot with D23 (4/Fig. 1).
- Attach guide rails.
- Plug board D25 back in.
- Check DIP switches on board D23. Switches 3, 4 and 6 must be "ON". The position of all other switches is arbitrary.
- Plug in board D23.

- Solder interconnecting wire 0.5 on board from socket connector X1 b4 (1/Fig. 4) to the 5th resistor (2/Fig. 3 and 2/Fig. 4) viewed from the socket connector.
- Stick label printed with the new part number 11 56 731 over the old part number 89 49 505 G5334 on board.
- Affix label D24 at position (3/Fig. 1).
- Cover old designation D20a on the frame with new label D24.
